SALMON AND STEELHEAD HABITAT LIMITING FACTORS

**WATER RESOURCE INVENTORY AREA 16
DOSEWALLIPS-SKOKOMISH BASIN**

**WASHINGTON STATE
CONSERVATION COMMISSION**

FINAL REPORT

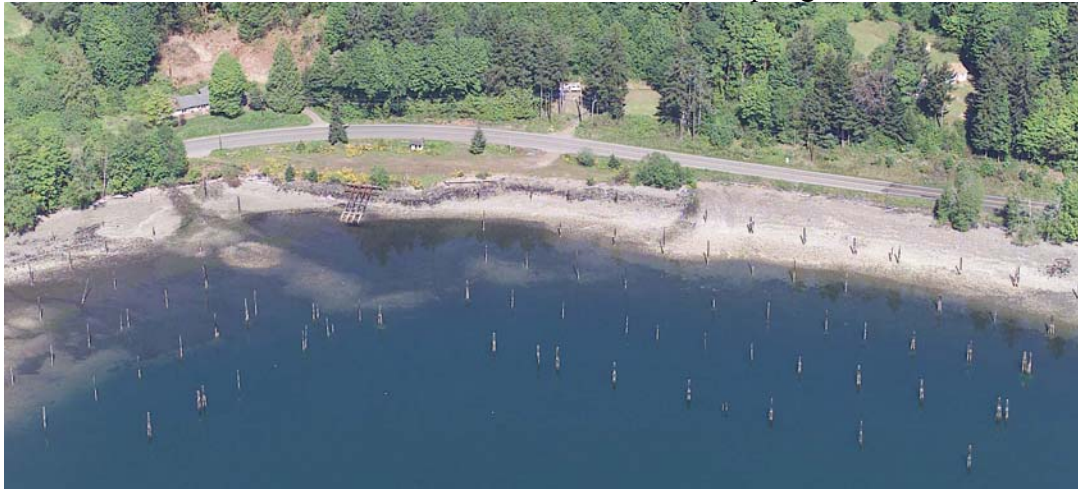
Figure 86. Creosoted pilings and log skid apparatus to north of Jorsted Creek, 2000. Ecology oblique photo # 101538.

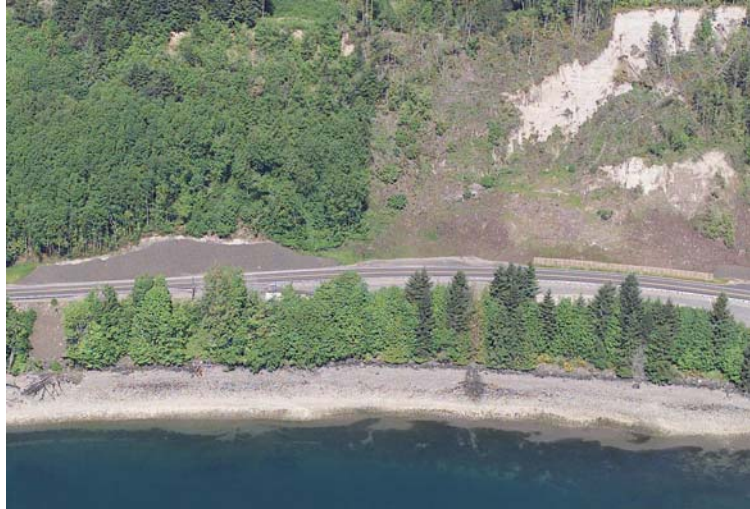
Figure 91. Sediment supply interruption by SR 101 south of Jorsted Creek, 2000. Ecology oblique photo #101450.

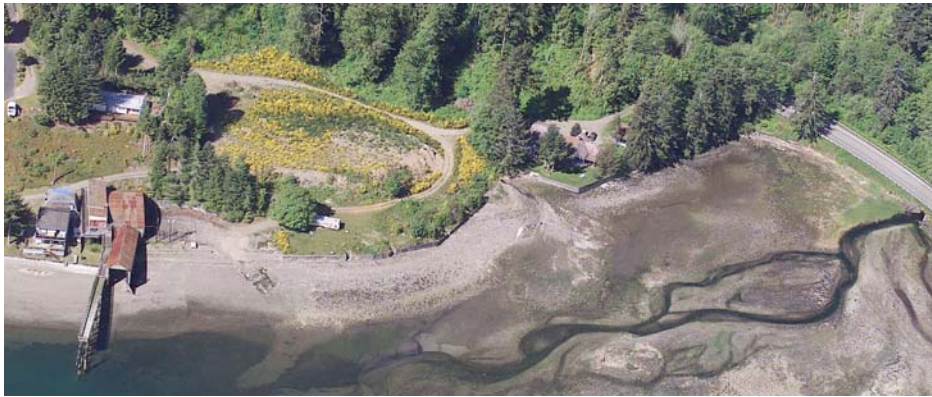
Figure 92. Undersized culvert, armoring, fill and boathouse at Little Lilliwaup Estuary, 2000. Ecology photo #100914.

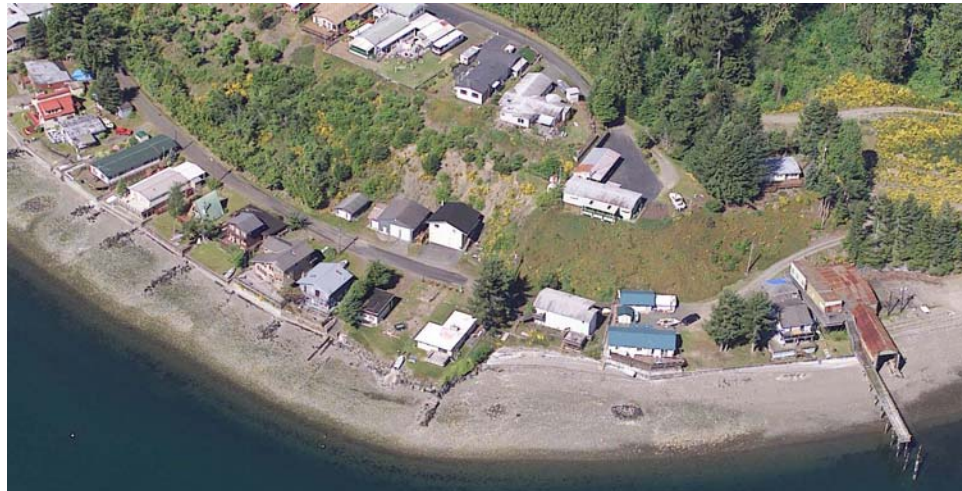
Figure 93. Bulkhead, fill, over-water structures and groins at Little Lilliwaup Point, 2000. Ecology oblique photo #100908.
